12th GLOBAL CONGRESS ON MANUFACTURING AND MANAGEMENT, GCMM 2014

## Radiography and Corrosion Analysis of Sub-merged Friction Stir Welding of AA6061-T6 alloy

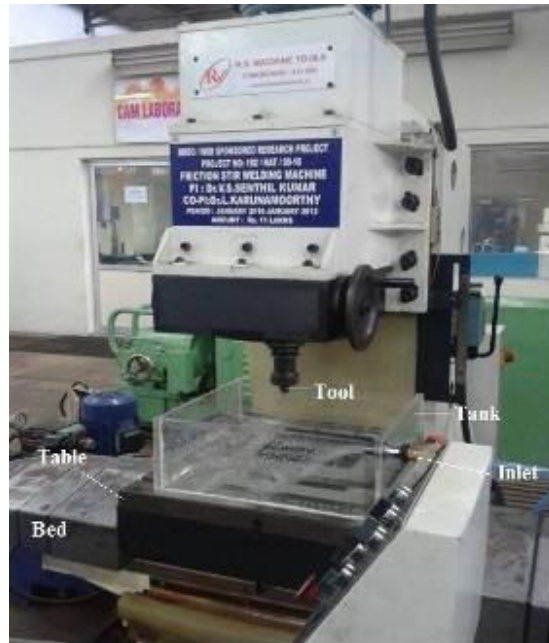
For the experimental of SFSW on AA 6061-T6, the material selected for the fixture used, was mild steel (0.3 % C). AKRYLIK (Plexi-Glass) was chosen as the material of the tank. This material has been chosen for the sole purpose of the vicinity of the friction stir welding. This material also aids in the direct measure of the level of the water used in the tank. Fig.1. shows the experimental setup of underwater FSW.

Fig. 1. Submerged friction stir welding experimental set-up

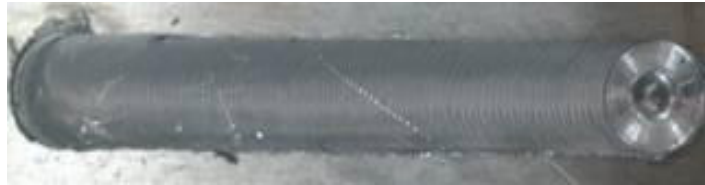
Typical welds produced at 1200 rpm, 45 mm/min and water level 75 mm are presented in Fig. 5. Due to the nature of the surface appearances of the submerged friction stir welded samples, it was difficult to observe any surface defects. No significant cracks, voids, wormholes or other surface deformities were observed in any of the weld samples produced.

Fig.5. SFSW pieces of combination of 1200 rpm, 45 mm/min at a water level of 75 mm

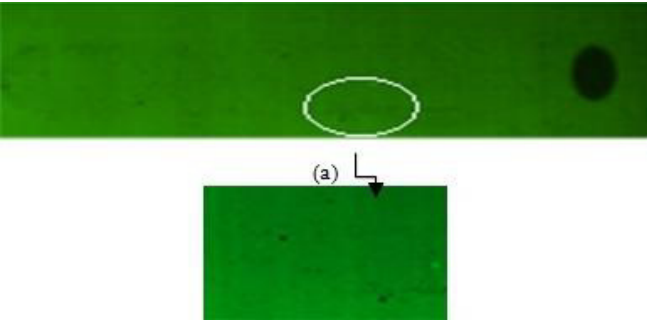
Voids defect is depicted.

The results of the radiographic tests conducted on all the welds produced at 1000 rpm, 45mm/min, and different water levels at 45, 60 & 75 mm, are shown in Table 3. With reference to Table 3, a void defect was found at the joint interface at high water level. The results of the radiographic tests conducted on all the welds produced at 1200 rpm, 60 mm/min and different water levels of 45, 60 & 75 mm are presented in table 4. With reference to table 4, worm holes defects were found at water level 75 respectively. In Table 2, Table 3 and Table 4, (a) and (b) show defects over the weld region, and enhanced view of the defects respectively. Internal cracks, voids and wormhole defects were identified at water level 75 mm from the radiographic test. It was observed that, more bubbles were developed towards the welding direction when underwater friction stir welding was performed at higher water level. This may lead to defects in the weld region due to lesser degree of fusion.

Table 3. Radiograph of welds 1000 rpm, 45 mm/min and water level 45, 60 &amp; 75 mm

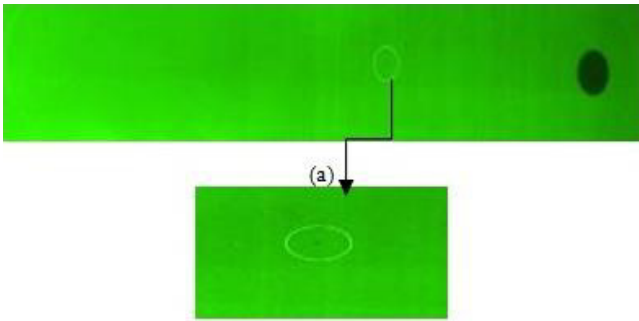
Worm-holes defects over the weld region.

Table 4. Radiograph of welds 1200 rpm, 60 mm/min and water level 45, 60 &amp; 75 mm
